Saraswati Setia

C.V.R. Murty

V.K. Sehgal

Soft-Storey Damages in Multi- Storied Buildings: A Critical Review

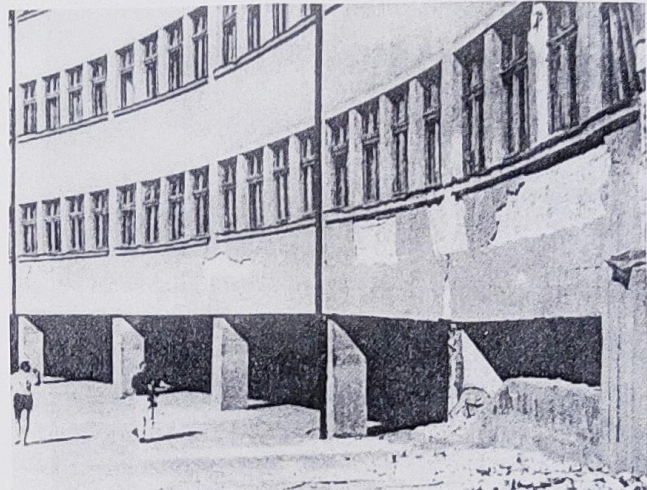
Major cause of soft storey failures identified was non-adherence to already existing codes, which were based on fundamental guiding principles of seismic design. Some columns of the building were shorter hence stiffer than the others which caused them to draw more seismic forces that they could resist.

This kind of failure is termed as short column failure. Fig.1 and Fig. 2 demonstrate this type of failure in a Feminine Secondary School. The two damaged column were shorter than the other columns hence stiffer suffered more severe damage.

Fig. 1: Open first storey failure

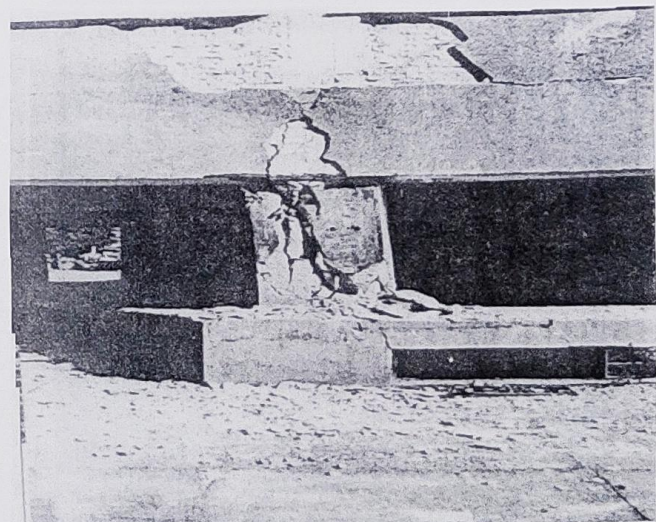
Fig. 2: Column failure due to short Column effect

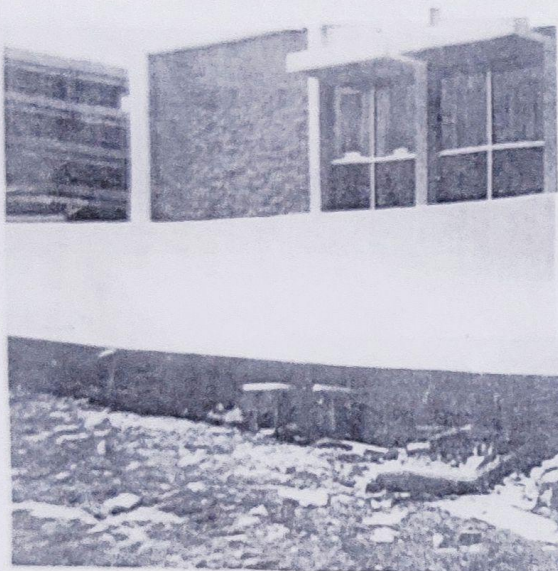
Olive View Hospital in the San Fernando Valley (Greater Los Angeles, USA), a new structure which was badly damaged due to a discontinuous shear wall is a classic case of failure occurring due to stiffness disparities. Vertical configuration of the main building was a two storey layer of rigid frames on which was supported a four-storey shear wall frame structure. Severe damage occurred in soft storey portion. Upper floors moved so much as a rigid unit that the huge displacement could not be accommodated by the lower columns. The largest amount by which a column was left permanently out of plumb was $2\frac{1}{2}$ feet as seen in Fig.3.

Fig. 3: Olive View Psychiatric Unit, second

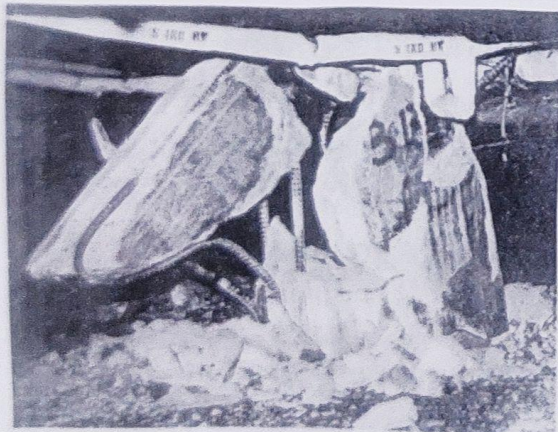
The lower storey columns were crushed and Fig.4 also shows the absence of transverse ties indicating bad ductile detailing.

Fig. 4: Shear failure of RC Column in ground storey floor rests on tables and chairs

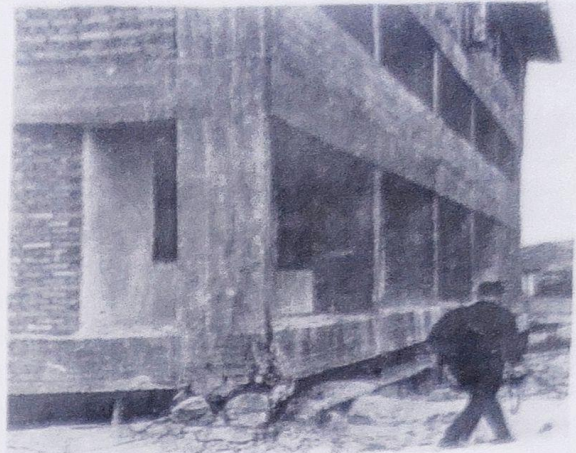
Fig.5: A close-up showing shattered columns, and some cracking of brick interior columns in the basement were free to deflect over their entire height whereas the exterior columns were greatly restrained by the heavy basement wall.

columns which were free to deflect over their entire height whereas the exterior columns were greatly restrained by the heavy basement wall. This great difference in stiffness resulted in the entire lateral load being resisted by the exterior columns, and consequently suffering all the damage. Note that columns are weaker in the longitudinal direction of the building, but column damage appears to be caused chiefly by motions in the transverse direction.

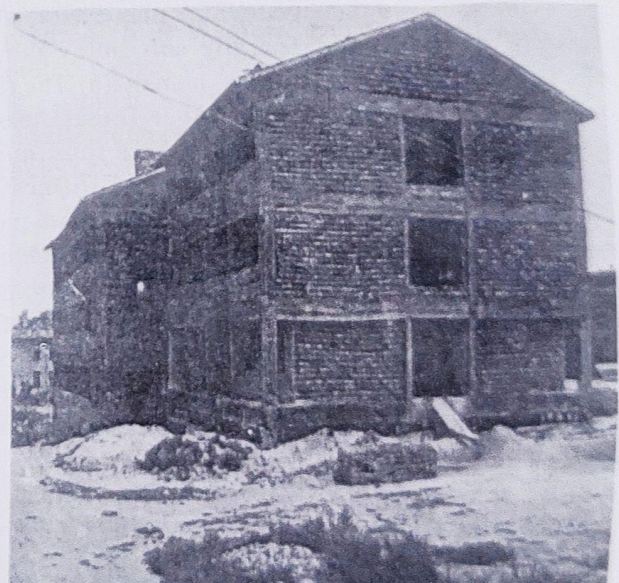
Poor quality construction materials, unskilled poor workmanship and lack of adequate knowledge of capacity design concept where the failure of vertical members namely the columns is to be preceded by the beam failure caused numerous failures in this earthquake. Stiffness disparities, no ductility provision and weak columns were the causes as shown in the (Figs. 5 and 6). Columns of the building in Fig.5 were the basement

Fig.6: Under construction, across the street from Burdur's hospital, is this 3-storey school, of rather common design in Turkey. Every exterior column, between the top of the foundation wall and the bottom of the first floor, was shattered, causing the building to settle slightly. There was also minor damage to brickwork at roof level and in the first storey.

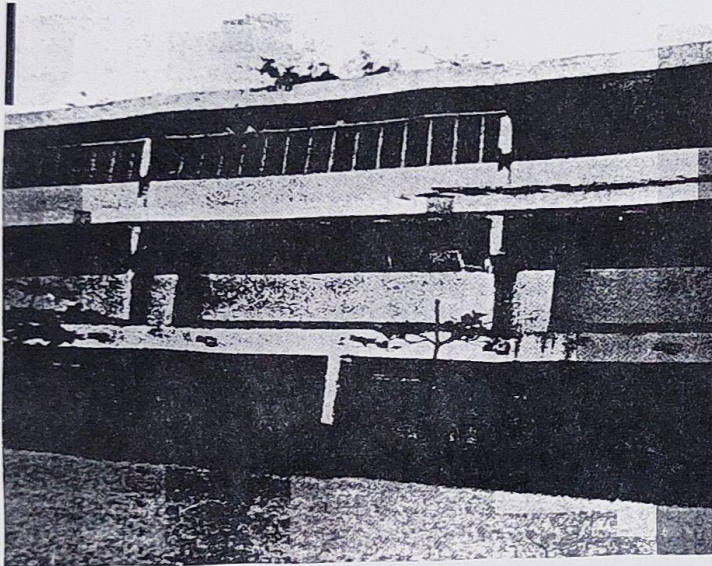
A 3 storey classroom building at Teressiano School had a column failure in 1968 Managua Earthquake. Repair was accomplished by building RC piers along the damaged columns upto the level of second storey windowsills. The remaining column height was unchanged. In the 1972 earthquake, damage occurred in the second and third storeys as seen in Fig.7. Repair altered the dynamic behaviour of entire structure.

Fig.7: Damage to Teresiano School building repaired after 1968 earthquake.

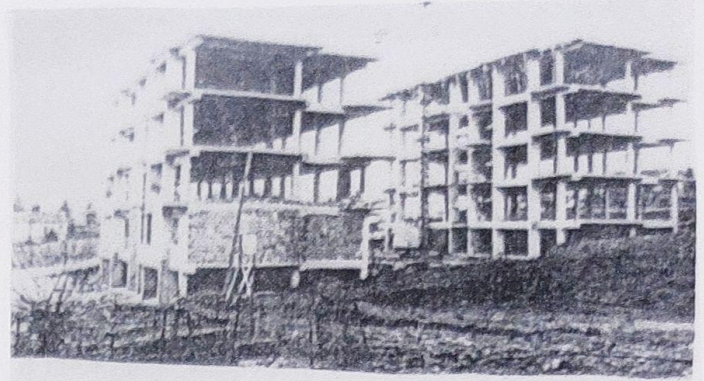
The 5-storey hospital building in Gemona (Fig.8) had partition walls of hollow clay tile. The second floor had far less clay tile in filled walls than other stories, creating an abrupt decrease in stiffness in that storey. Fig.9 shows damage of partially constructed building due to randomly distributed masonry infill walls in the 1980 Earthquake.

Fig. 8: Five storey eastern wing of Gemona Hospital. The second story had a discontinuity of partition walls, creating a more flexible storey

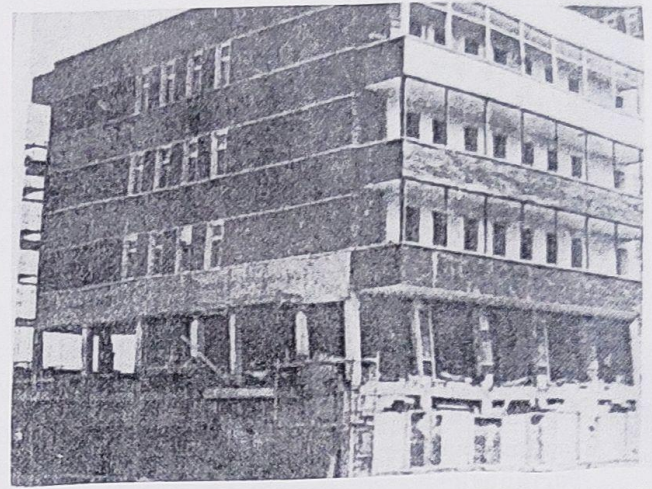
Fig. 9: Randomly distributed Masonry infill in a partially constructed building

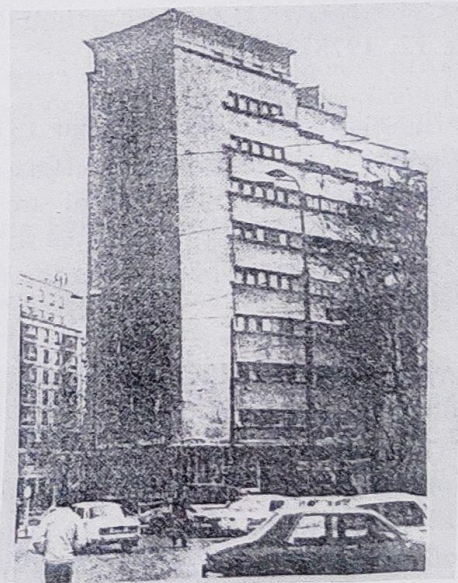
Fig.10: Apartment building with soft ground story designed and constructed prior to the 1940 Romanian earthquake.

damage due to both the earthquakes caused collapse. Lateral code provisions were implemented only after 1940 earthquake. Quality of concrete was poor, though the most fatal cause was the open first storey.

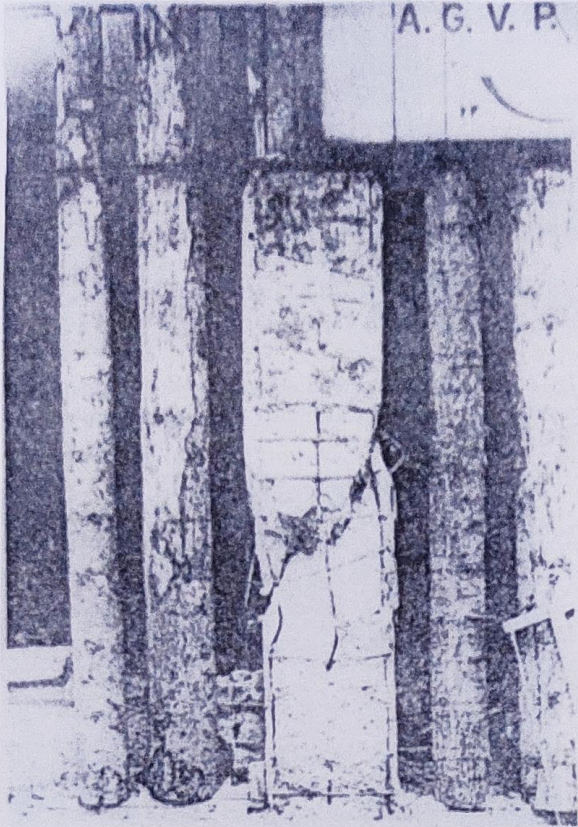
Fig.11: Column in the open ground story of tall building designed and constructed before the 1940 Romanian earthquake.

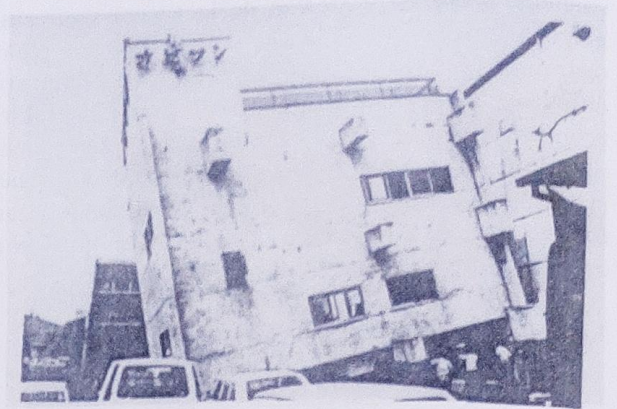
The Obisan Building (Figs.12 and 13) was a 3 storied structure. Due to combined effect of a soft storey and eccentric stairwell, torsional stresses were induced due to the earthquake causing the stiffer upper stories to rotate as a rigid body when the first floor columns collapsed.

Fig.12: Obisan Building Oroshicho area, Sendai: view from the northwest. This is a 3-storey reinforced concrete frame building with a soft first story, one span in each direction. The columns were inadequate to resist the torsional force caused by a heavy eccentric stairwell that cantilevered over the column line at the right end of the building.

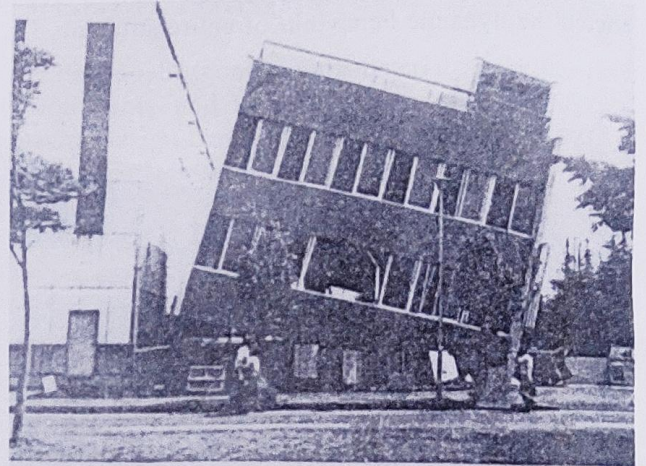
Fig.13: Obisan Building Oroshicho area, Sendai: view from the south. The upper stories rotated as a rigid body when the first-floor column support was lost.

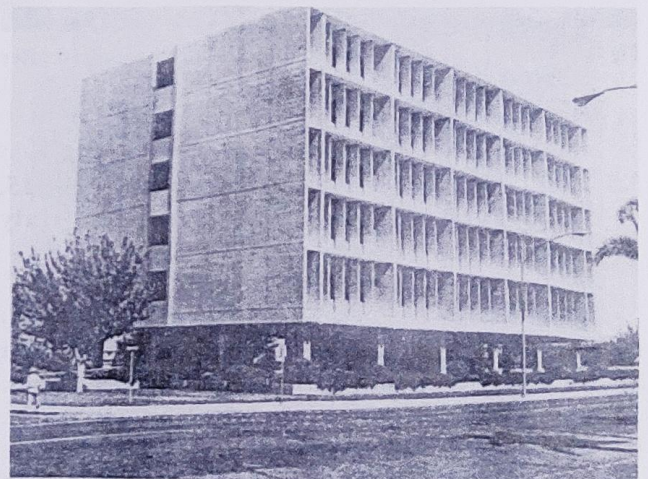
Fig.14: Imperial County Services Building, El Centro (Photo by John Robb, LA Department Building and Safety)

The performance of Imperial County Services Building, El Centro (Figs.14 and 15) provides another example of architectural characteristics on seismic resistance. Origin of this failure lies in the discontinuous shear wall at end of the building. The west end had shear wall upto the foundation. While the east end had

it discontinued at the second floor, this small variation caused a major failure.

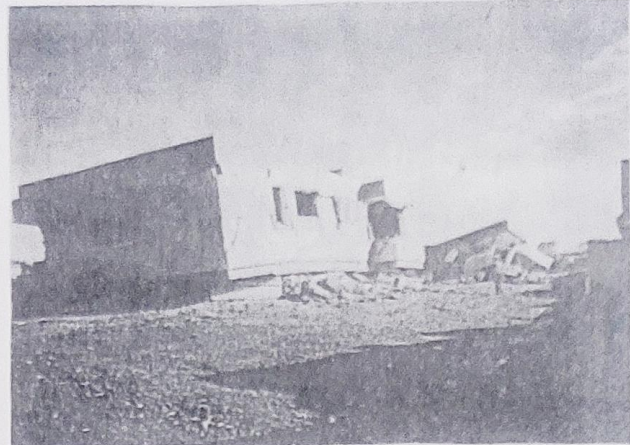
Fig.17: Collapsed two-story houses under construction in Boucaa Sahnoun that had soft first story

The cause of soft storey damages was attributed to a prevalent construction practice in El Asnam. A use of *vide sanitaire*, a crawl space about 3 feet above ground level. Only structural elements in this space were 3 feet tall columns without any interior partition or walls. Perimeter masonry walls were used to enclose this space. Structure above this was in filled with stiff masonry walls. These *vide sanitaire* constituted a soft storey with very short columns lethal combination. Building inclined as much as 20° and dropped 1 m causing damage of first storey while other stories were undamaged (Figs. 16 and 17).

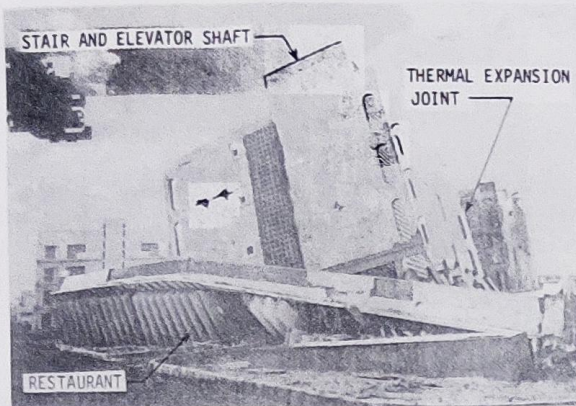
Fig.16: Collapsed first-story restaurant

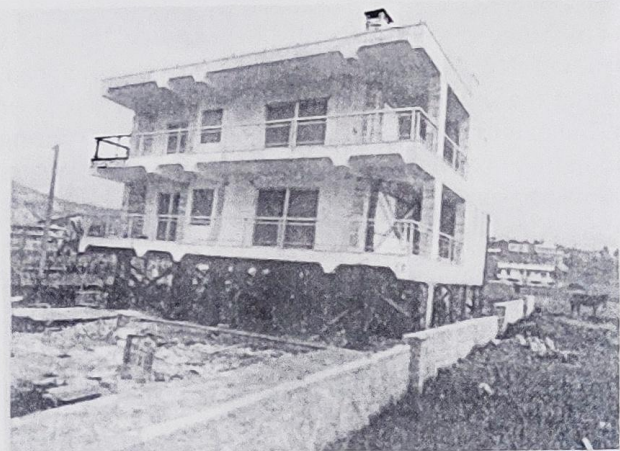
storey. Rigidity in upper stories was due to large partition, relatively low storey height and presence of many deep beams (Fig. 18). Performance of those types of structures was very poor owing to large disparity in stiffness values.

Fig.18: Modern resort apartment building in Alephohori with open first story. The damage was limited to the lower story. The heavy scaffolding (placed after the earthquake) consists of H-shaped steel beams.

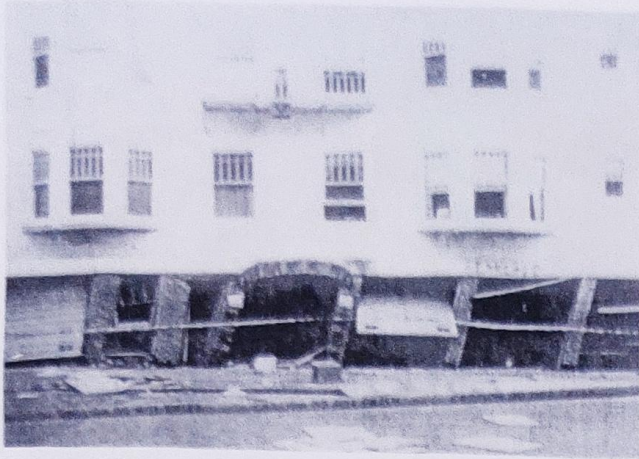
Researchers determined that soft first stories were a major contributor's upto 8% of serious failures. Actual percentage may be more because many failures precipitated by this condition. Fig.19 shows a building with a open first storey which was situated on soft soil deposits which aggravated the situation further.

Fig.19: Many of the buildings that failed in the Marina District of San Francisco were particularly vulnerable because of the lateral weakness of the first story caused by many openings, such as for garages. Many of the most severely damaged buildings in this area were outside the original shoreline on filled areas. These soft soils experienced more severe shaking than adjacent firm soil sites and in some cases liquefied.

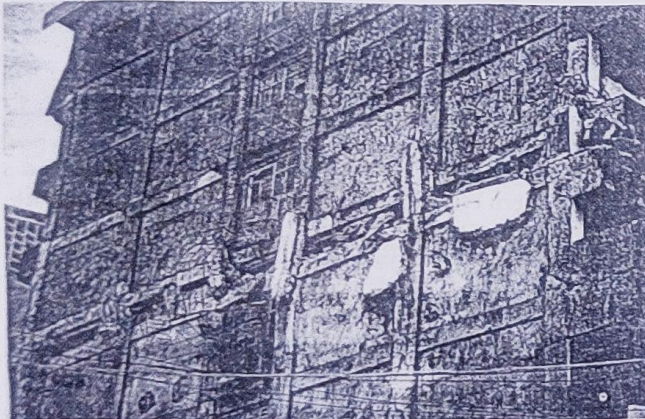
in Fig.20 had block work in fills. Being brittle, the panels disintegrated as soon as their strength was reached. Falling masonry was a considerable hazard to passer by. Behaviour of structure became unpredictable during the earthquake due to an abrupt change in stiffness following panel failure causing the soft storey collapse to occur.

Fig.20: Soft-storey failure in frame building with infill blocks work, Philippines earthquake 1990. (Photo: Ove Arup & Partners)

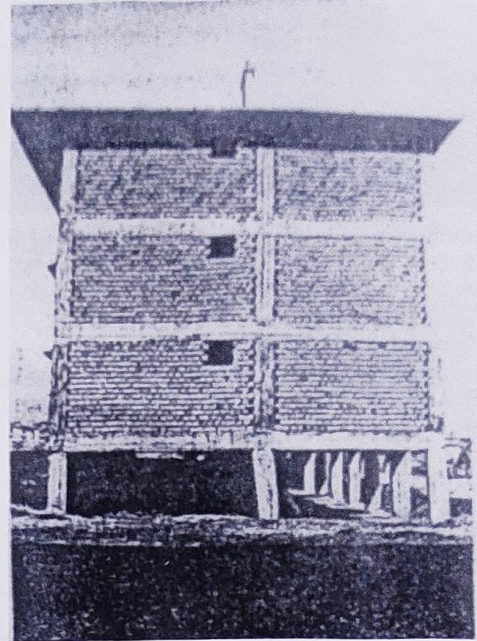
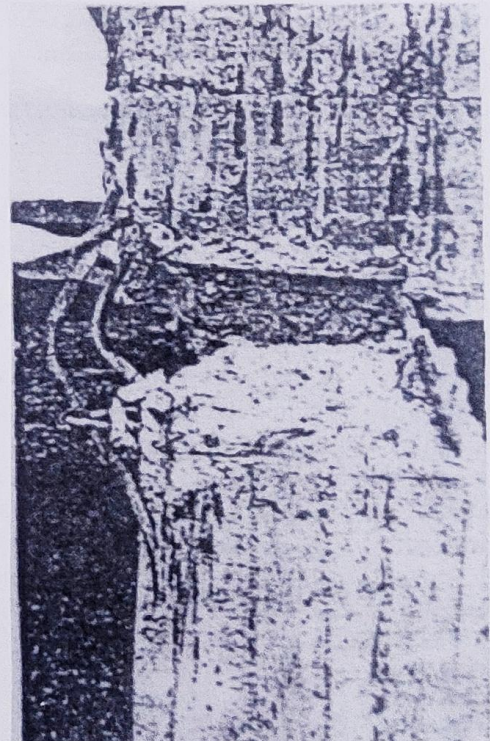
In Fig.21, the building has block work infill and open first storey. This cause large increase in strength and stiffness at upper floor in relation to first storey.

Fig.21: (a) Soft storey created by block work infill, Erzincan, Turkey, 1992; and (b) Detail at top of ground-floor column on the left in (a). (Photo: Ove Arup & Partners).

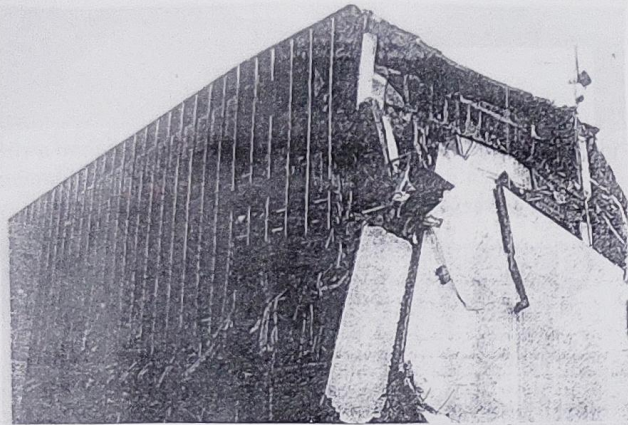
Fig.22 shows a medical office building which suffered damage in the 1994 Northridge earthquake due to discontinuous shear wall at each end. These proved inadequate to deal with the forces with consequent severe torsional damage at each end of the building. Fig.23 shows another first storey collapse of Northridge Meadows Apartment Complex killing 16 people.

Fig.22: Discontinuous shear wall failure, office building, Northridge

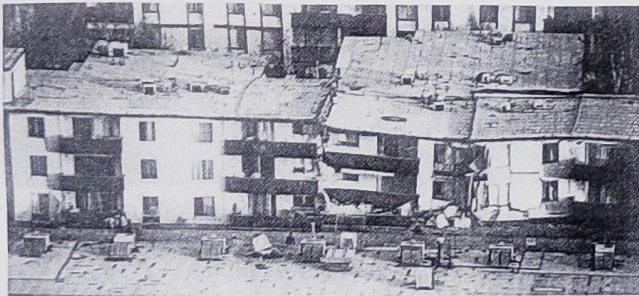
Fig.23: Northridge Meadows Apartment Complex where 16 people died in the partial collapse of the first story. (LA Times Photos).

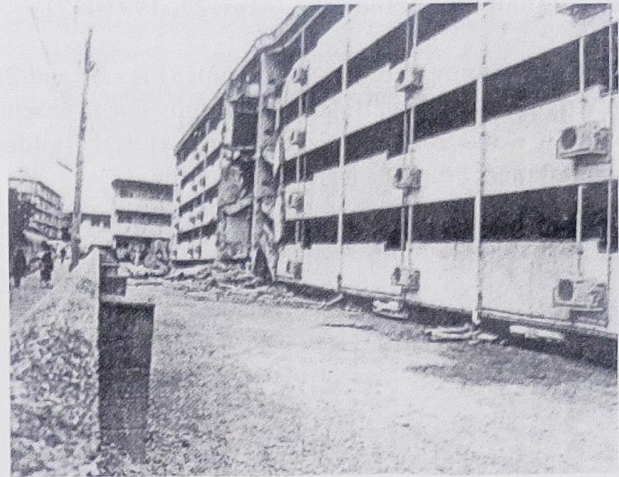
Figs. 24, and 25 speak for themselves. The 5 storey apartment is resting over the vehicles parked in the open first story.

Fig. 24: Collapse of the first story

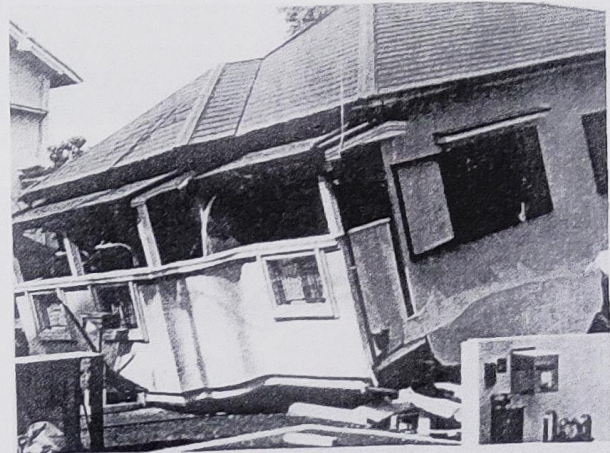
Fig.25: 2 story apartment house building: collapse of the first piloti floor.

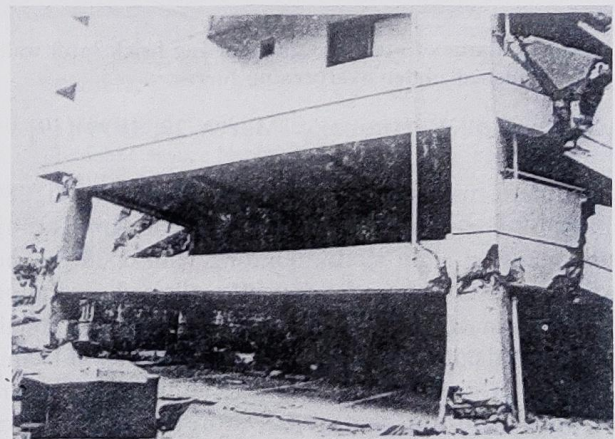
Fig.26: Fracture of the top and base of columns

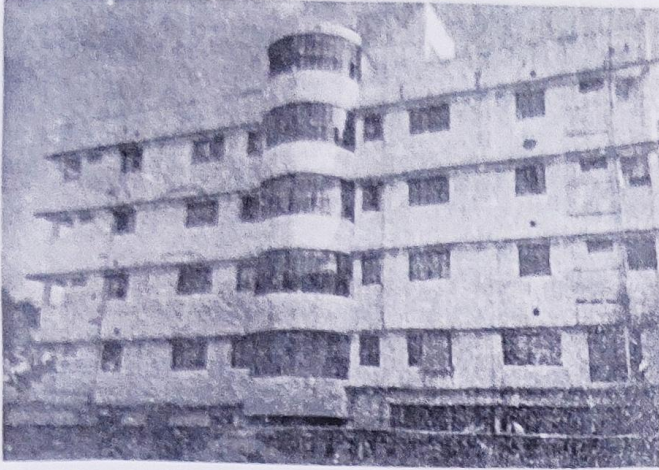
Fig. 27: 5 Storey Himgiri apartments, Wrighty Town

Five-storey Himgiri Apartments (Figs.27 and 28) in Wright Town has vertical discontinuity due to absence of infill walls in first storey. A Youth Hostel Building had columns crushed in the open storey.

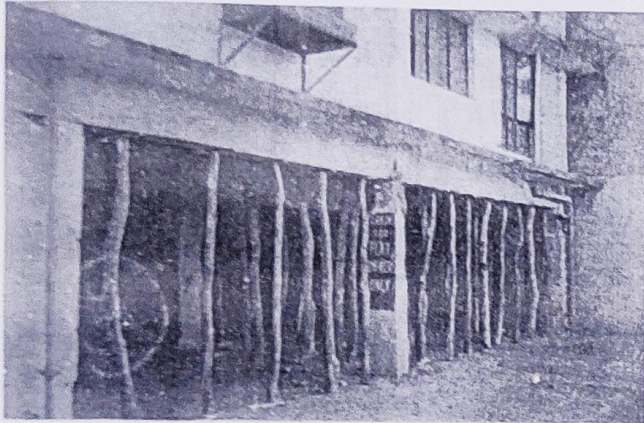
Fig. 28: Columns of open bays supporting brick infill walls crushed under overturning forces.

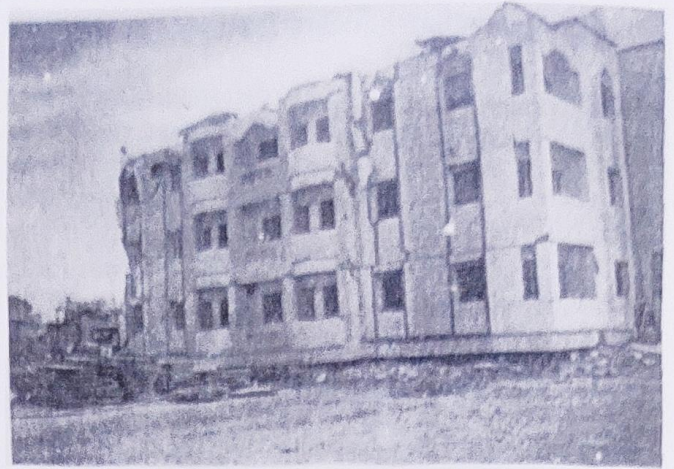
Fig.29: Collapse of apartment building in Ahmedabad owing to open ground story failure. No structural damage is observed in the upper stories.

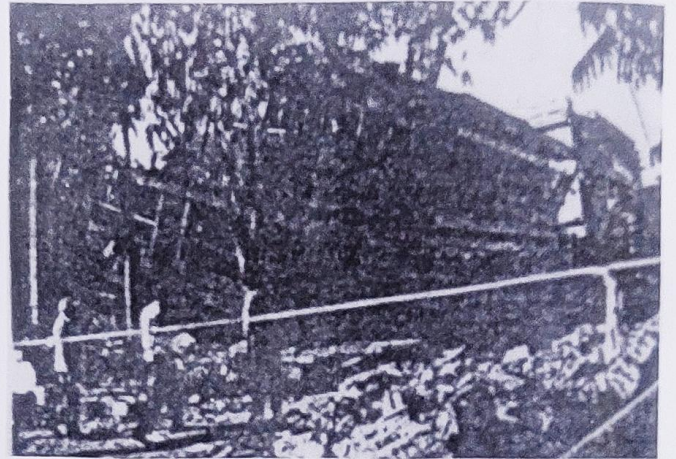
Fig. 30: Complete collapse of apartment building in Ahmedabad, a building with an open ground story and poor reinforcement detailing
