Systematic Fact Finding and Problem Solving for Leakage in High Pressure Line in Diesel Engine

Keywords— HP line leakage, Diesel engine.

Tata Motors, Pune
Pimpri, Pune, Maharashtra, India

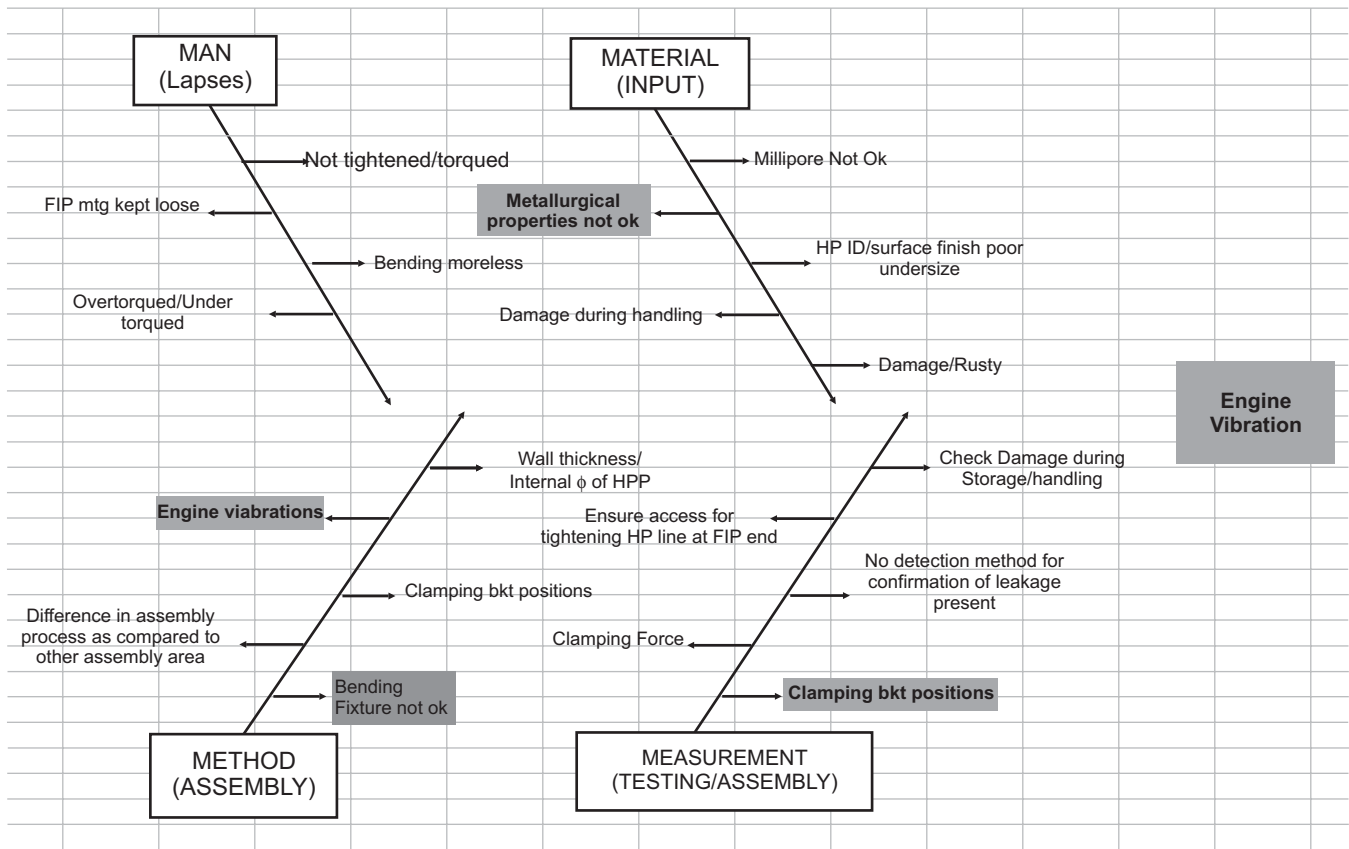
Fig. 2: Fishbone Diagram for HP line Leakage root causes

As shown in figure 2 the main root causes are highlighted which were Metallurgical properties of brackets, engine vibration, and clamping bracket position. So studying causes one by one the assembly method on engine line is investigated first, i.e. procedure for assembly performed by workers during fitment of HPP from FIP to Injector, we found some lapses those are;

Important points among above were the design issues. Due to gap between brackets often at workstation it was forcefully fitted with plastic hammer. So incurred stresses in the material may cause of concern. Measurement of distance between brackets revealed that the gap between the two brackets is less than ideal resulting in imbalanced structure.

As per suggested by engineering research center at TML, the existing material was found to be incompatible with high pressures during engine operations. EN32 was identified was good material for such type of application but the incurring cost of design change at vendors was as high as five times of the existing. So the material properties were decided to be supported by better vibration proof design. Vibration analysis of the structure showed that the support structure for hp line needed to be redesign.

the vendors. And found that one of the bending fixtures may be causing cracks on the line.

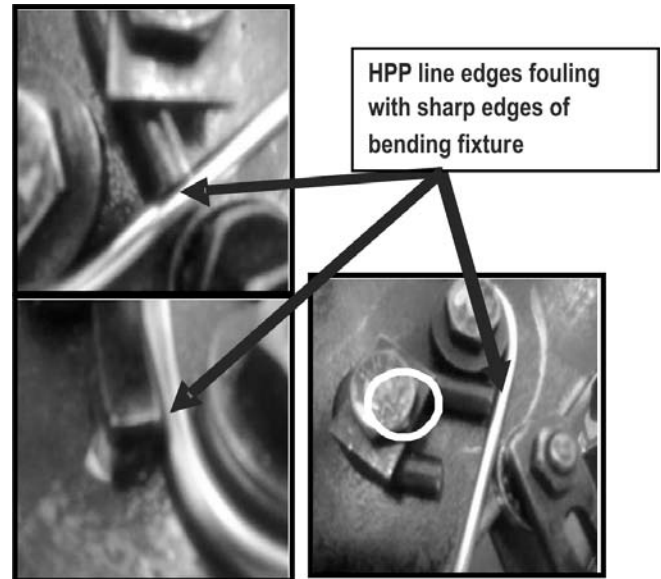
Fig. 4: Bending Fixture left: previous right: new [5]

4. **HPP line edges fouling with sharp edges of bending fixture**

Bending more / less - 100 % Bending is checked at supplier end on master engine. (One person is dedicated on daily basis from vendor to TML). And as well the master bending fixture is redesigned for the

issues found during cause analysis study as shown in Fig. 4. The change in the design is highlighted by blue circle.
